**Texas Gulf Coast Refinery:**

**Coated cooling water exchangers:** These pictures were taken after 2 years in service. These bundles were brought down during a turnaround and when opened this is what they looked like. There was no cleaning (hydro-blasting) done to the exchangers. Tubes were dried out with compressed air and a video probe was run down them for inspection. Other bundles that were in the same unit and operation were fouled, pulled, and replaced with new bundles. **Coated bundles were not:**

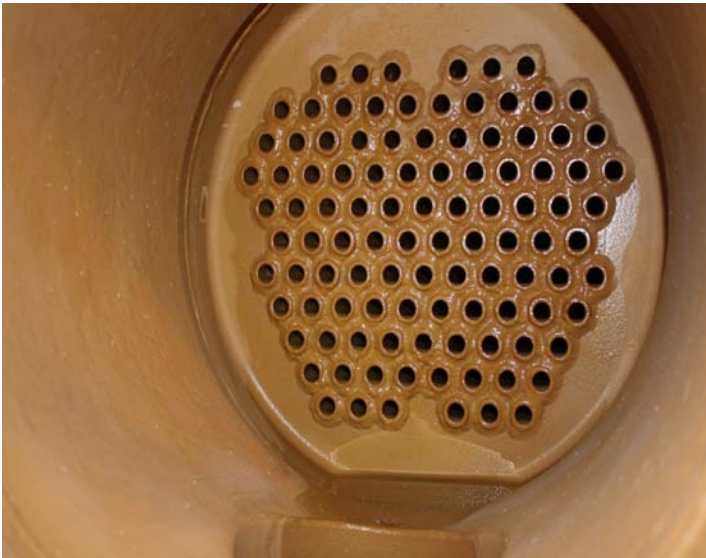
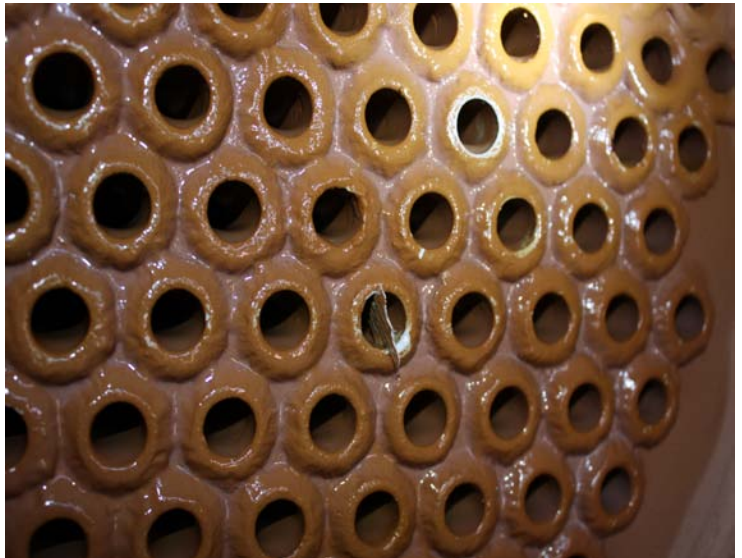
**Above:** After 2 years in service. Damage seen on right is simple mechanical damage from debris hitting tube sheet.

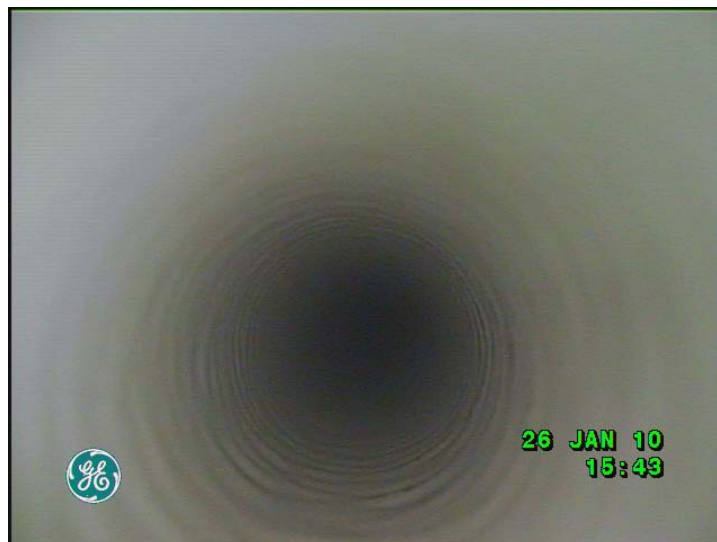
**Below:** picture of same tube ID
