Blast Cleaning of Aluminum Brass Exchanger

Aluminum Brass cooling water exchanger
192 tubes X 18feet long. 1 inch OD with 16 wall

A Gulf Coast Refinery in the USA

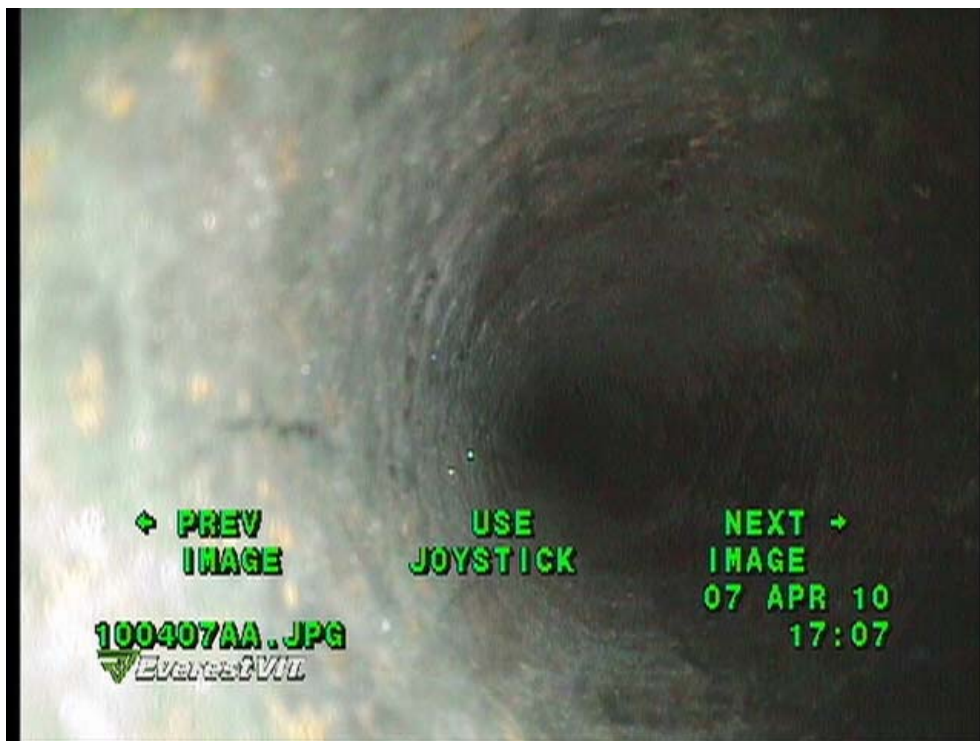
Service: Hot service Brine/Cooling tower water on the ID was forming calcium scale on the tube walls.

Picture below is of aluminum brass tube after the tube had been hydro blasted.

Client unable to get tube ID clean enough with hydro blasting. Curran International was called in to perform patented grit blasting method.

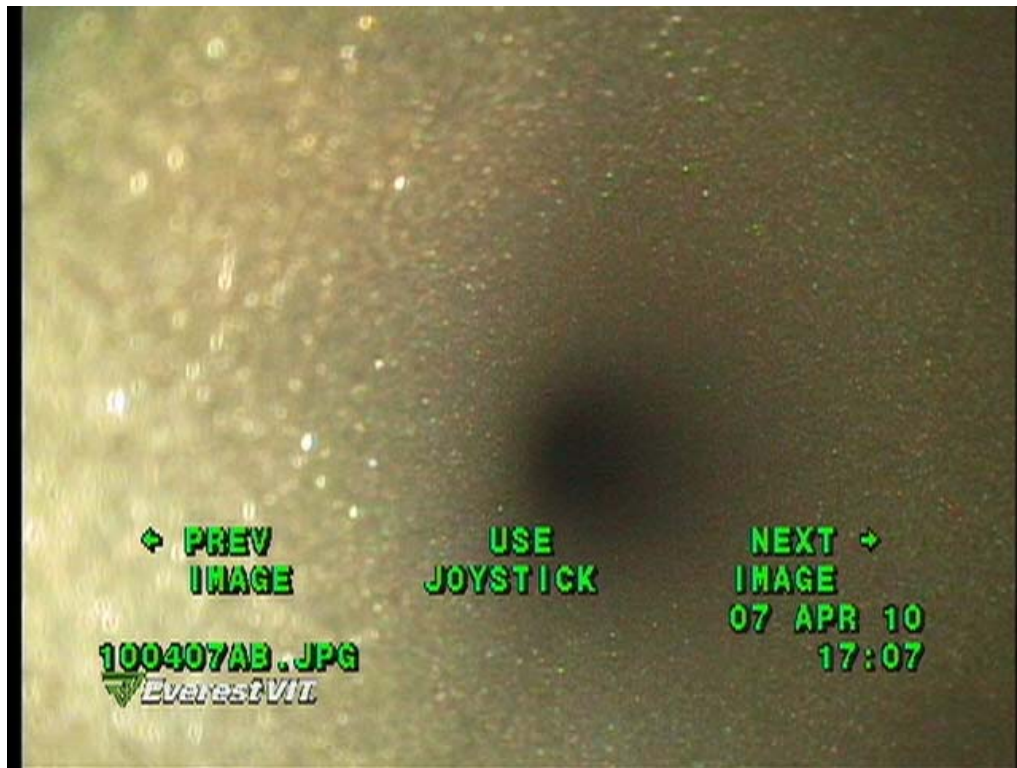
Picture below is of same tube after being grit blasted for 15 seconds. Tube is cleaned to white metal.

Curran crew was able to clean all tubes within one shift. Blast times on the tubes were 15 seconds per tube.
