## Increased Tube ID Flow Rates, Improved HTR; 20% Improvement of $\Delta T$ at Process Outlet

## Alky Unit: Improved Duty, Reduced Expense

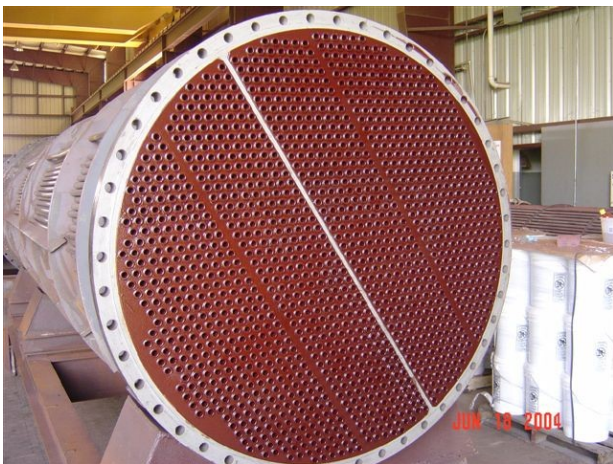
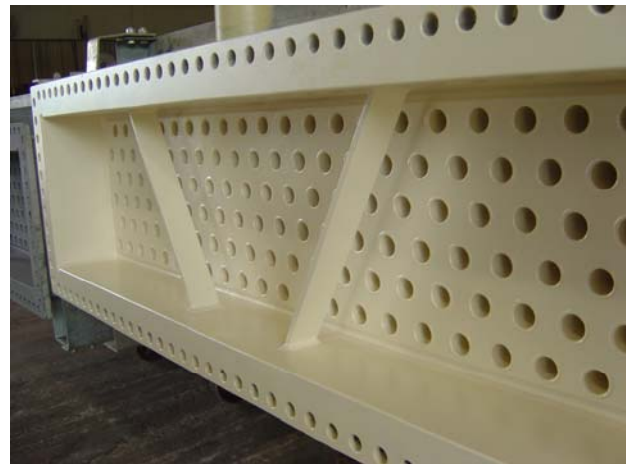
**Full length tube ID coating – an exchanger bundle (left) and a fin fan air cooler – coated with  $<.010$ ” film of coating. A polymerized, homogenous thin film applied down full length tube IDs reduces friction and drag at the substrate. Tube ID coating sustains flow of cooling water through tubes; by reducing fouling and “backpressure” long term performance of the carbon steel exchanger is realized. Normal bundle maintenance, including hydroblasting, is reduced or eliminated. Contact Curran International for project references.**
