Tube-sheet Coating to repair a problem with Galvanic Attack

Carbon steel tube sheet and skeleton with a 1/4" stainless tube sheet cladding and tubes.

PDVS Curacao Refinery (heat exchanger)
500 tubes (1,000 tube ends)
3/4" OD and 20' long

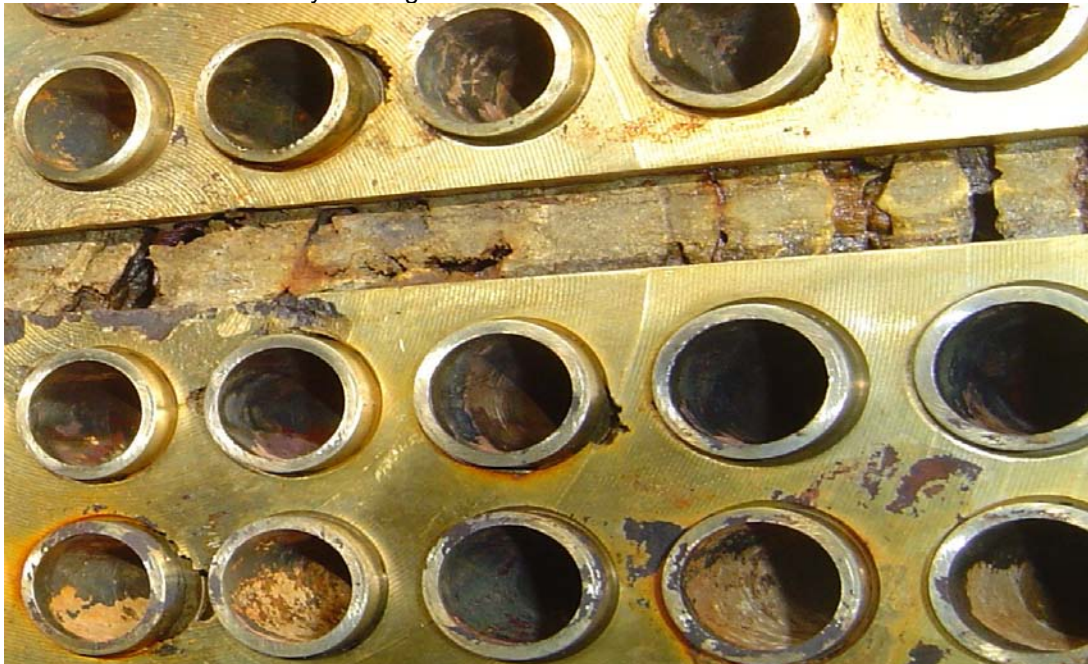
Pictures shows the severity of the galvanic attack.

Damage can be seen affecting the out side of the tube-sheet and the gasket area

Curran International mobilized to the job site, performed surface preparation, and applied 30-40 mils of an Curran Ambient cured epoxy to tube-sheets and 3-4 inches down tube.

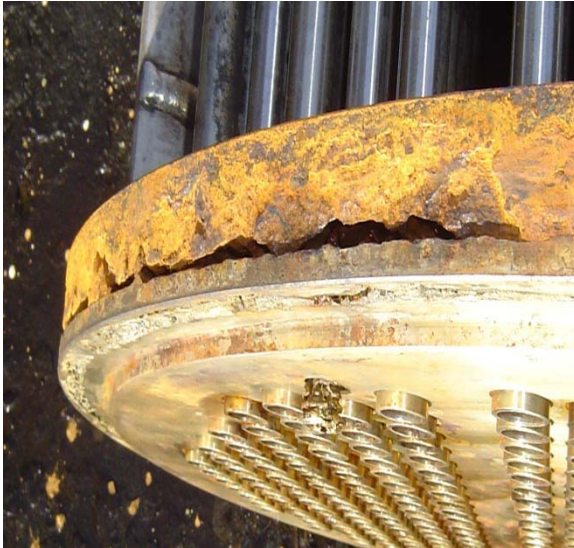
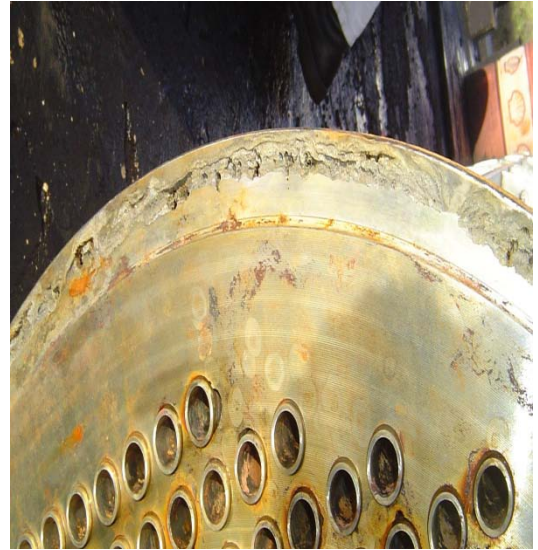
Tube-sheet being machined to attain the desired coating thickness on the gasket areas

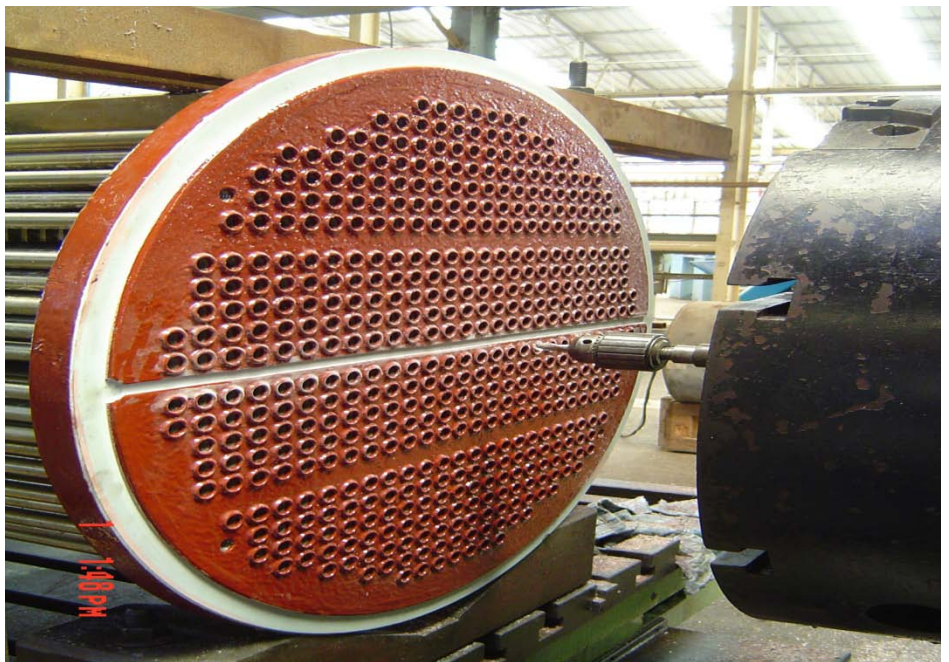
Applying coating solutions

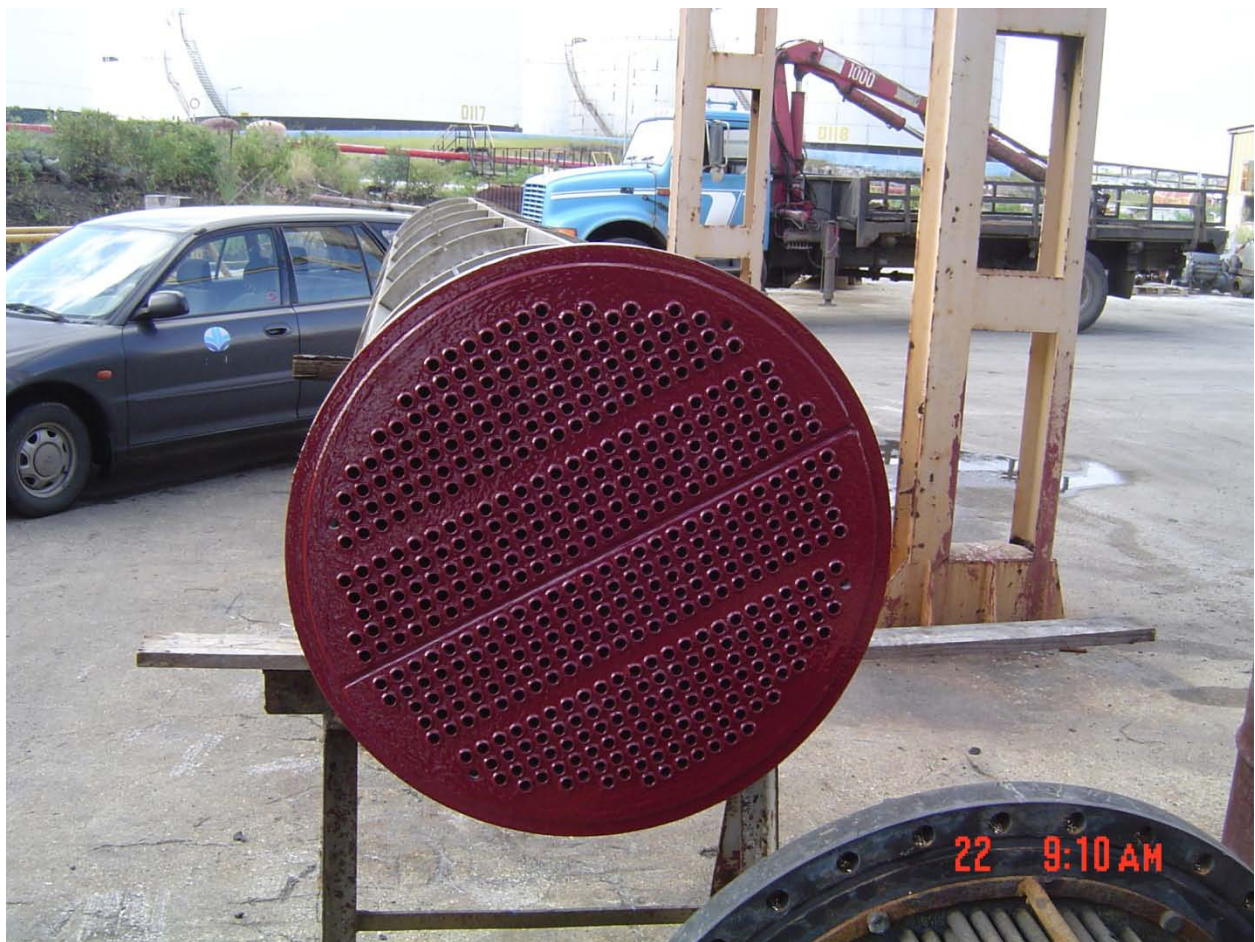
Chiller after completion of coating application. Client able to insert coated chiller and has eliminated the galvanic attack problem. Curran has since coated 3 additional chillers for this client. All work done according to NACE procedures for surface preparation and coating application.
