Tube Coating Can Create Perpetual Life For Exchangers

Extend the Useful Life of Your Heat Exchangers with Full-length Liners

Clean Tube IDs Produce High integrity NDE Data

Inspections Right in Curran's Shop

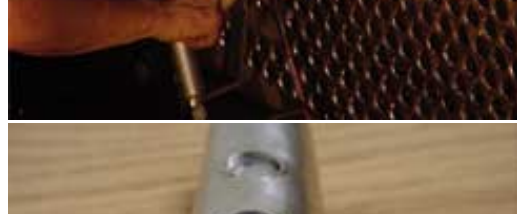
Picture 2 (Bottom Left): A hydraulic liner seals off two tube defects.

- **FULL-LENGTH LINERS:** Full-length liners are installed as an alternative to full re-tubes of straight tube heat exchangers. The liners are installed into leaking tubes to recover them and bring the unit back close to original design parameters. The full-length liners are also installed into tubes that have been found by NDE to be close to failure. Such installation eliminates the need for an emergency shutdown required to plug the tubes. The liners are hydraulically expanded the full length of the tube to make contact with the tube. The liners also add wall thickness.

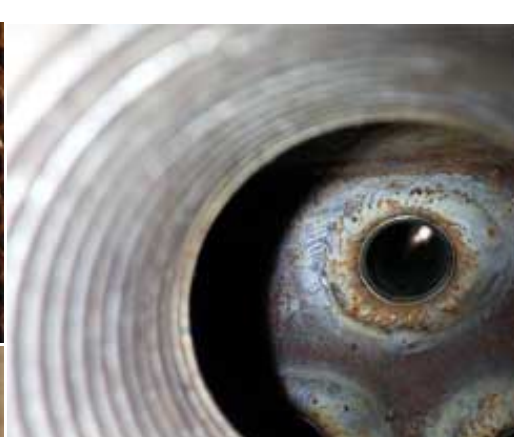
Picture 3 (Right): End view of a liner installed through a fin fan box header.
