May, 2017

# Keeping Benzene Where It Belongs

# Save on Energy Costs Due to Fouled Boiler Tubes

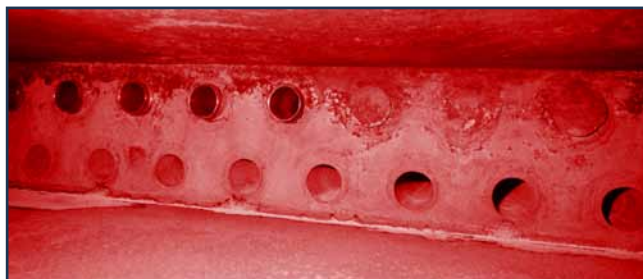
Upon arrival at the plant, Curran technicians inspected the benzene condensers in question. Curran noted the flow of benzene through the condenser headers was eroding the tube-to-tubesheet welds, which lead to compromised tube joints. Once the tube joints were compromised, the benzene began passing through the tube-to-tubesheet annulus and venting out through the backside of the header tube plate.

Header Tube Plate as Found

After consultation with the plant personnel, Curran was informed that the plant was only experiencing issues with the west-end headers. Therefore, a decision was made to grit blast the west-end header tubesheets, wrappers and covers.

Once the grit blast cleaning was completed, Curran applied a coating of Curran 1500 to these components. Curran 1500 is an advanced two-part (100% solids) epoxy coating designed specifically for high temperature immersion service in water and process streams (up to 365 F, 185 C).

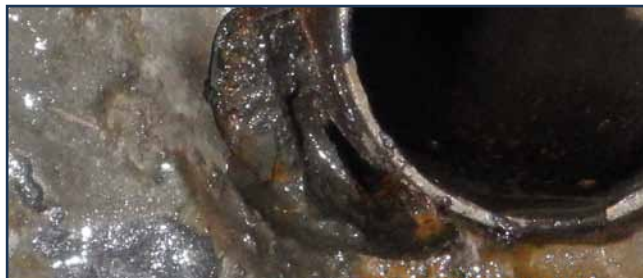
Hole at the Tube to Tubesheet Interface

This coating is an organic/inorganic hybrid with state of the art coating technology. Additionally, since the condenser was also experiencing tube leaks, the decision was made to install full length AL-6XN liners.

The liners were installed using the hydraulic expansion method. This is done by expanding the liner the full length of the parent tube, using hydraulic pressure ensuring a positive, full length liner to parent tube mating.

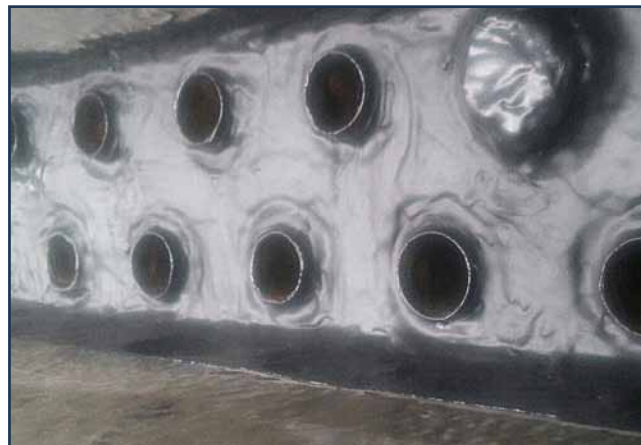
Tube Plate After Coating

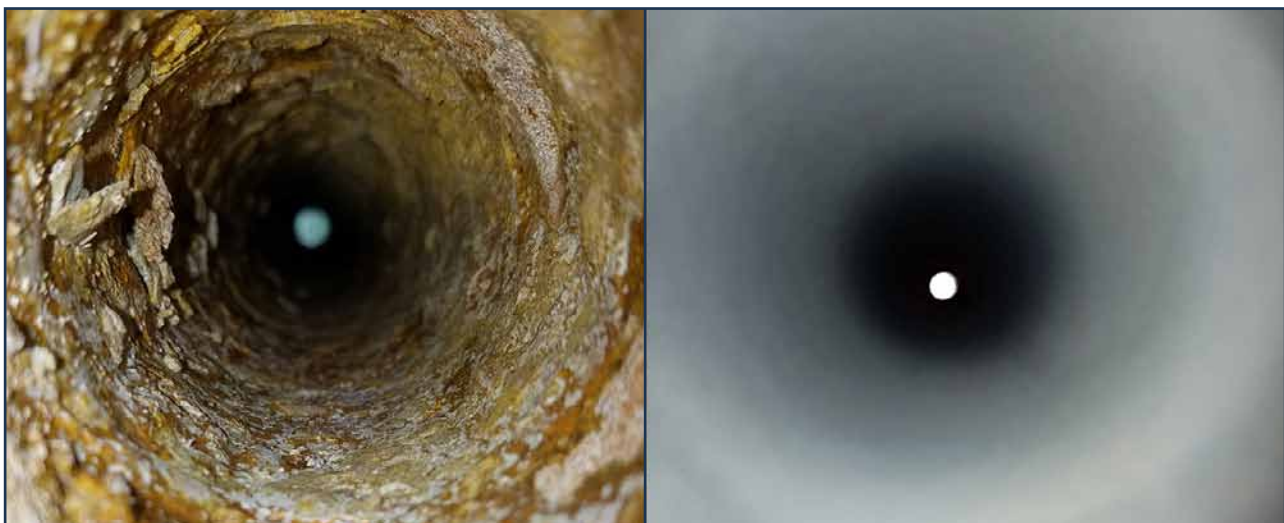
Image of fouled tube ID (L) in sulfur service: risk of under deposit corrosion and impact heat transfer; grit blasted tube (R) facilitates accurate NDE, and returns heat transfer duty. Dry grit does not react with sulfur waste debris, and is highly containable.

Curran takes tubes with thick scales and blasts bulk debris from IDs in 30 seconds. What you would find is the more tenacious rock-hard deposits prove grit blasting to be highly effective. Cleaner tubes minimize under-deposit corrosion.

Curran has evolved its tube ID cleaning methods for large boiler and heater tubes that experience heavy buildup due waste gases condensing downtube. Grit flows at a high velocity downtube scouring the tube ID. This has proven to be a very effective method that renders tubes NDE clean, even cleaning pits downtube.
