December, 2017

Protect, Prolong Exchanger Service-Life

Hydraulically Expanded Liners Restore Corroded Exchangers

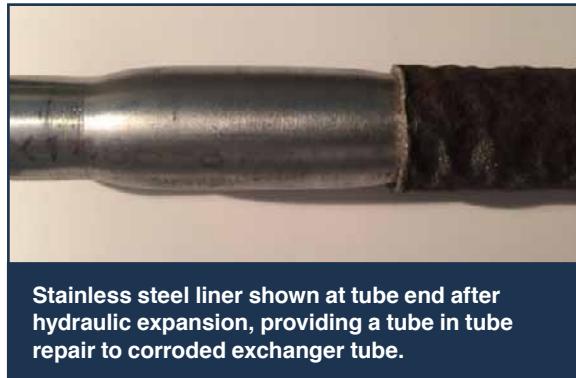
Stainless steel liner shown at tube end after hydraulic expansion, providing a tube in tube repair to corroded exchanger tube.

Alloy tube liners are another repair option for restoring corroded exchanger tubing, resulting in a tube-in-tube repair using a corrosion resistant light wall tubing. The alloy liner is hydraulically expanded the full length of the existing, or "parent" tube, with enough residual pressure to achieve an intimate contact between the inner and parent tubes. See the animation demonstrating hydraulic tube installation at www.curranintl.com.

Hydraulic expansion closes the air gap between the liners/sleeve OD and the parent tube ID. This eliminates any possibly insulator affect by facilitating 100% metal to metal contact. This process can repair tubes with excessive wall loss, tubes with cracking or pitting, as well as tubes with through-the-wall defects.

Once the liners or sleeves have been installed, the tube ends are mechanically rolled to seal the ends. Excess liner is trimmed to the end of existing tube, or can be flared to enhance flow.

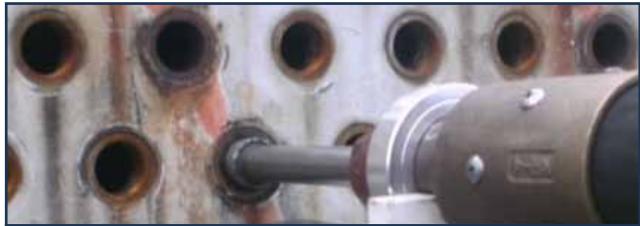
Curran specialized nozzles "bridge" and capture waste-grit and tube debris tube-end to tube-end.

Curran's method uses proprietary nozzles that are fitted to tube ID and "bridging" the headers. Dry grit is propelled down tube at high volume and velocity creating a turbulent flow that scours away deposits and scale.

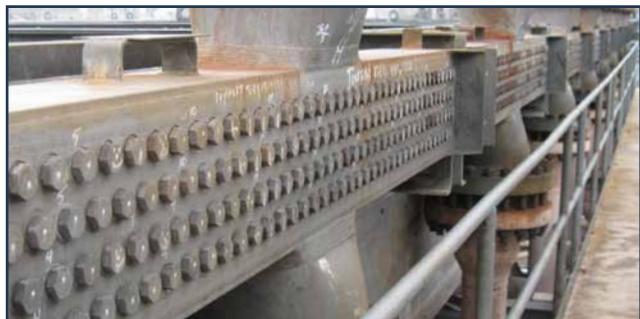
The Curran method eliminates containment setup on catwalks, thus keeping headers unencumbered and accessible.

The Curran air cooler tube cleaning method does not require tube lancing, so all work can be performed from existing catwalks. Blast waste is contained through the "exit header" and collected in a containment bin situated at grade below the fin fan.

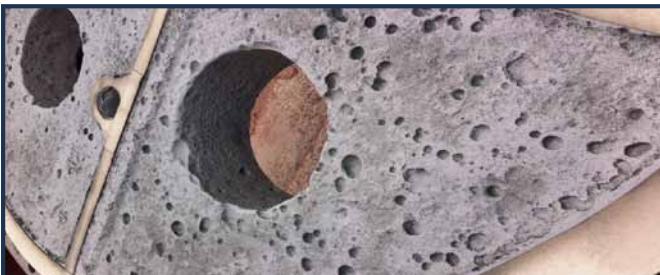
Channel in cooling water, pitted surface blasted clean exposing many pits deeper than 0.0625"

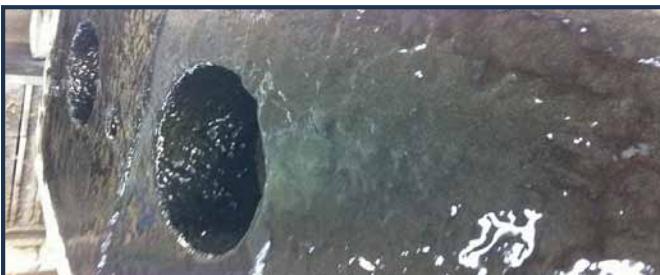
Curran 1500 was applied in 2-3 coats, total DFT averaged 0.100" creating a homogenous corrosion resistant film.

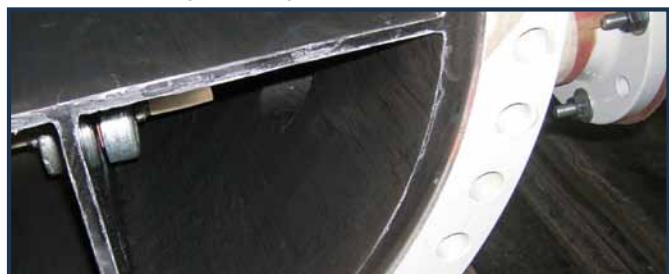
New fabrication heat exchanger channel, ID coated with Curran 1500, applied to 0.040" in a single coat.

The coating can be applied to new fabrication in a single coat to 0.040" DFT (Dry Film Thickness).
