## The Forefront of New Exchanger Coatings

### Foul Release Coatings for Process-Critical Exchangers

# Curran Coating Improved Cooling Capacity and Net FCC Production Gains

# Plant Specifies High Functionality Coating to Arrest Tube End Erosion

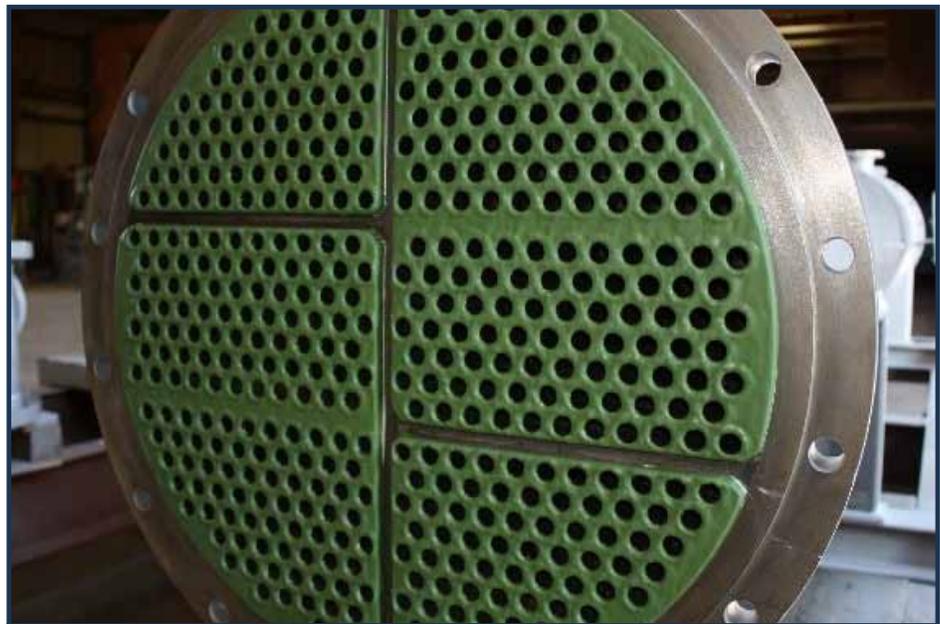
Curran coated exchanger improves refining cooling capacity, contributes to unit optimization.

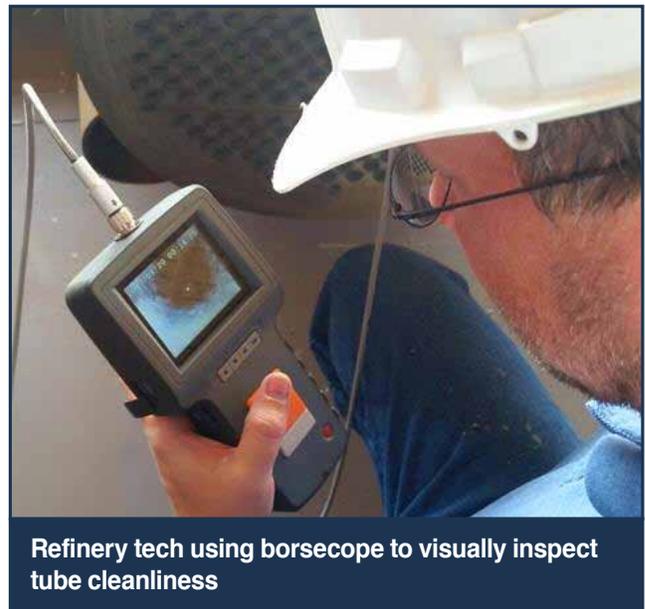
Refinery tech using borescope to visually inspect tube cleanliness

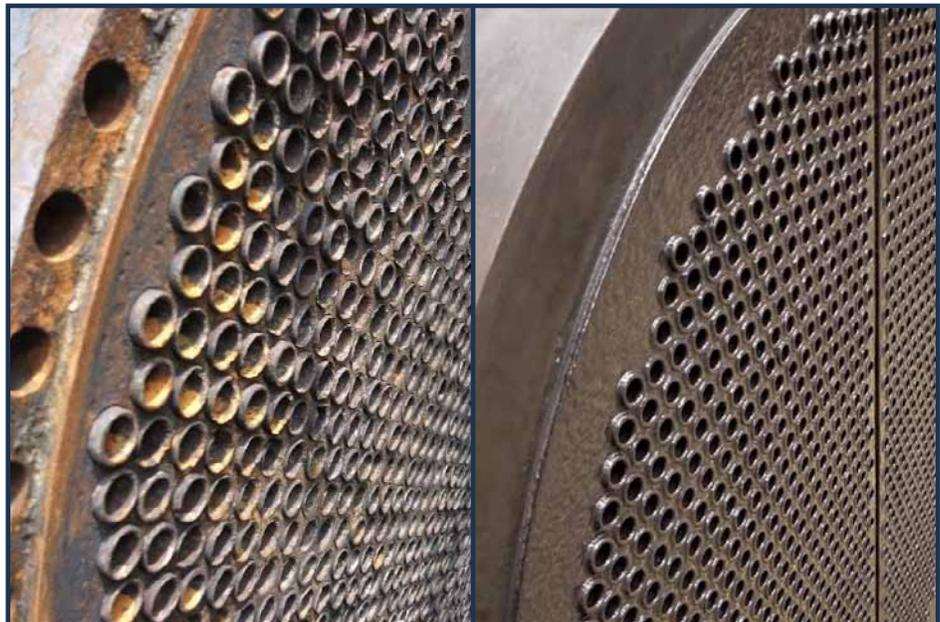
Images of tubesheet prior to coating; tube end erosion threatened sealing joint integrity. Image at right after coating tubesheets with Curran 1500, a 100% solids hybrid novolac for cold wall services.

While performing routine maintenance of quench water exchangers plant inspectors observed erosion at most tube end projections across the bundle. To complicate matters, many were eroded flush to tubesheet.

In the end, the remediation meant protecting sealing joints and encapsulating tube ends to arrest oxidation. To do this, the exchanger tubesheets would be coated.

- 1.) Curran technicians grit-blasted the tubesheets to NACE 1 white metal, inspected and remediated soluble contaminants (chlorides).
- 2.) Using a short bush, a primer coat was applied at tube and tubesheet joints, encapsulating the crevice to strengthen the seal. A thin film was wrapped over and into the tube end to about 3/4" down-tube to mitigate erosion and tube end wear.
- 3.) Two coats of Curran 1500 were applied, achieving about 32 to 40-mil total thickness across tubesheets.
