May, 2020

Heat Exchanger Foul Release Coatings for Crude Refining

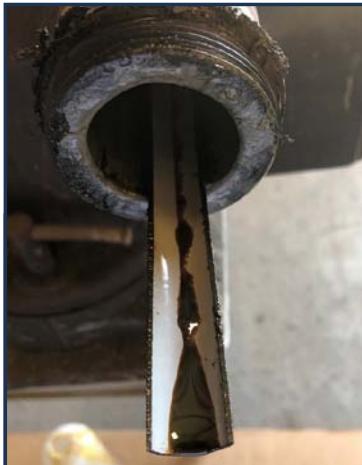
Curramix 3500 – 60 days static soak in test fixture at 650°F; crude oil flowing down coated tube.

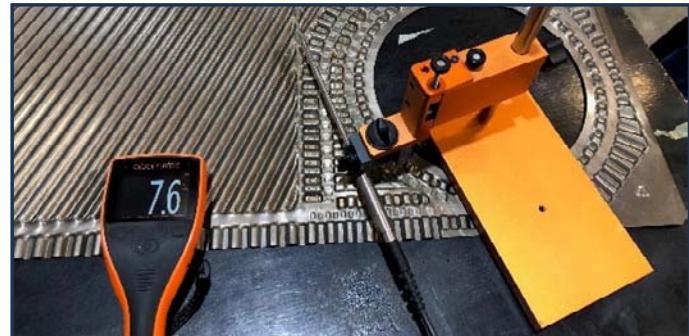
Ultra-thin Curran coating applied to PFE requires use of positioning jig to record precise film thickness measurements, instrument shows 7.6 microns thickness.

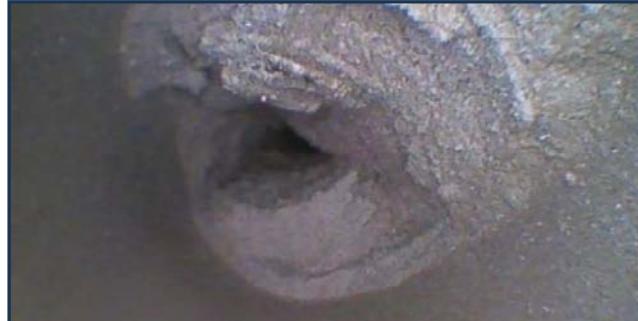
Salt water sediment and deposits severely fouled many of the condenser tubes requiring hydro lancing to clear.

Tube-pitting had already cost the plant about 10 percent of condenser operating duty. The tubes suffered under-deposit corrosion from seawater mineral scaling, pitting, leading to mechanical plugging.

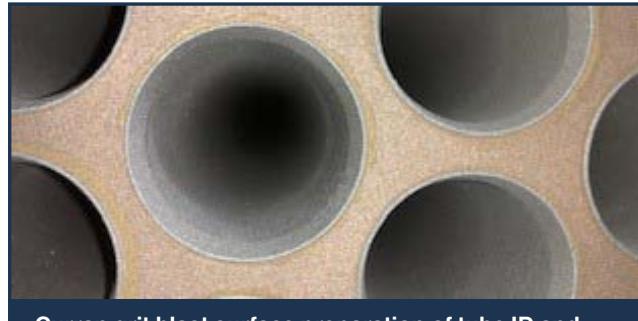
Curran grit blast surface preparation of tube ID and tubesheet yielded clean surface for coating.

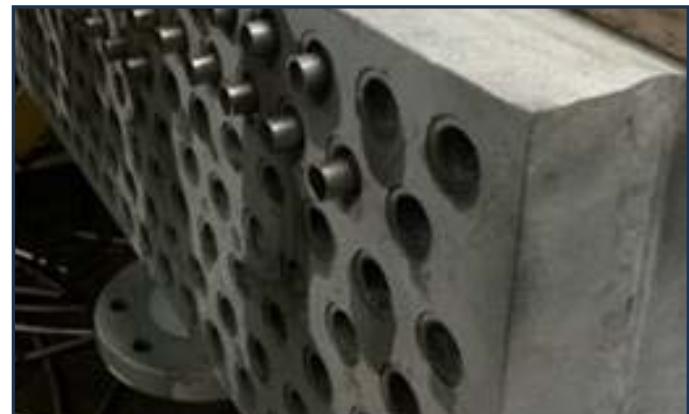
Full-length alloy liners used in a new fabrication replacement air cooler; client upgraded only primary inlet section where operating history showed tube corrosion was severe.

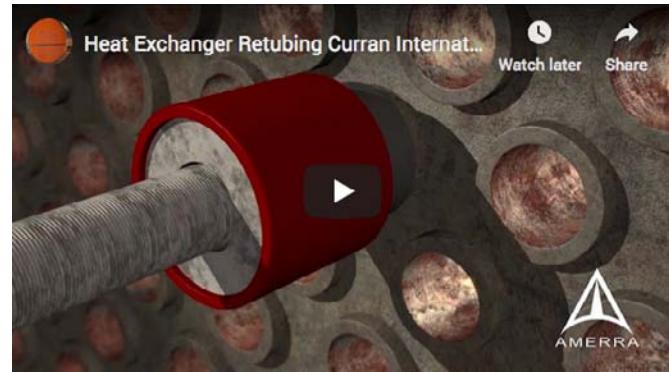
Full-length liners are sized carefully to fit down an existing exchanger tube. Curran works with several domestic and Western European-based steel mills to provide timely delivery and competitive pricing. Curran's inventory strategy supports exchanger integrity assessments, especially when a contingency repair plan must be implemented on just-in-time basis.

The common alloys used for tube liners include, C276, 825, Stainless Steel, Admiralty Brass and CuNi tube materials. Curran has installed seamless and welded tube materials for clients specifying liners tube wall thicknesses from 0.022" to 0.049" and in-between sizes.

Curran International installs and hydraulically expands alloy tube liners – the tube-in-tube installation achieves “intimate contact,” and a corrosion-resistant barrier. Full-length tube liners eliminate the need for tube plugging and, thus, keep the target-tubes in-operation.
