Curramix 3500™ Anti-Foul Coating

Improved Crude Preheat Exchanger Duty

Hydraulically-Expanded Tubing for Critical Exchanger Repairs

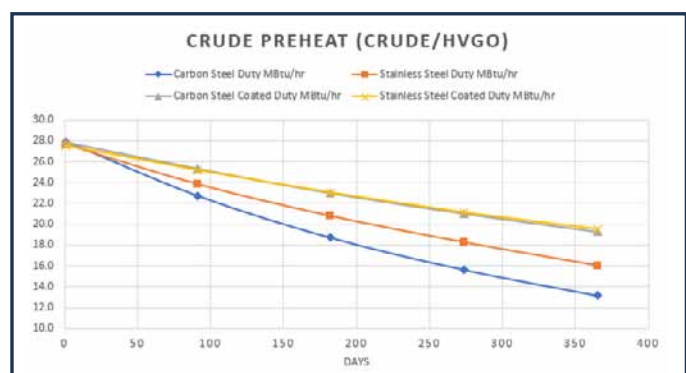
Study data projects the performance of coated versus uncoated exchangers over one year. Heat transfer efficiency, measured in millions of BTUs per hour, is shown on the vertical axis. The uncoated exchangers, orange and blue lines, show significantly reduced efficiency, as a result of fouling, compared to the coated exchangers, the yellow and gray lines.

The data projected that a Curramix 3500™-coated exchanger would operate at reduced backpressure, provide improved energy duty, and contribute significant CO2 savings.

The study also showed the coated exchanger would provide a \$173,000.00 maintenance and energy benefit-expenses compared to an uncoated-exchanger-over a two-year run. The study allowed for cleaning the uncoated exchanger at a one-year interval.

Analysis was performed on a typical TEMA AES exchanger found mid-train in crude preheat arrangement, processing desalted crude tube-side and HVGO shell-side. Tube-side and shell-side operating rates and temperatures, as well as fuel values and furnace efficiency are identified in the report.

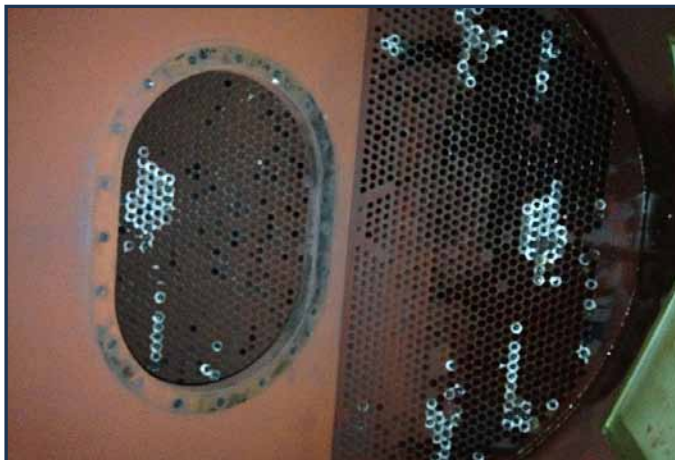
Desuperheater exchanger, image shows the tubesheet where about 400 tubes with greater than 70% surface indications and required repair liners were found. The image also shows tubes marked for repair.

After consultation with the facility's management, Curran determined the tube-end insert dimensions for sleeve-material recommended by the plant. Curran sourced a quick turn delivery of 1,200 alloy sleeves for installation. In just days following the plant's call, a Curran crew and tooling was onsite.

Shortly following the installation, the plant performed a hydro test without incident.
