## New Coating Materials Further Advance Anti-Foul Performance

# Restoration of Fixed Assets – Curran Coating Saves a Bundle!

# The Many Benefits of Curran Dry-Grit Tube-ID Cleaning

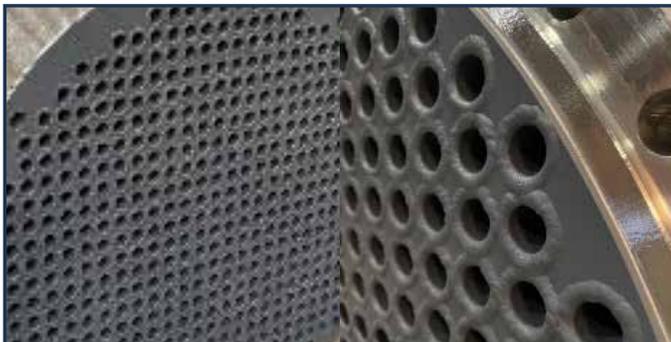
Duplex SS tube bundle coated with Curramic 3500™, a ceramic low-surface energy release coating applied at 30 microns total DFT.

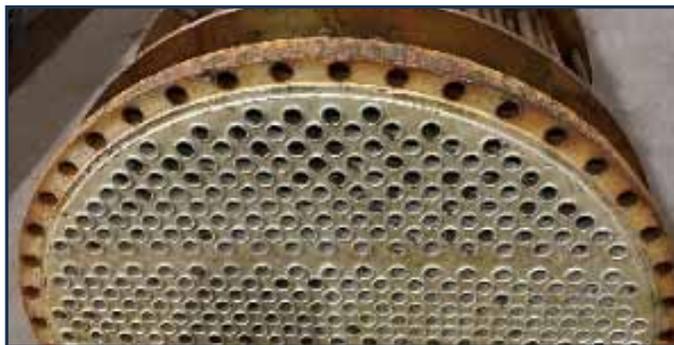
Tube bundle after 14 years of river water service

After more than 14-years of service, this Gulf Coast refinery planned replacement of a 304 stainless steel exchanger in a unit in which the cooling water is river water. After the exchanger was originally fabricated, tube-IDs and tubesheets were coated. Fourteen years later, when the exchanger was pulled for replacement, it passed a hydro test; and, prior reliability inspections had shown no signs of tube-degradation.

The refinery's equipment engineer, then, developed a scope of restoration work that included Curran cleaning and removing the downtube coating; as well as, ECT and IRIS NDE inspection, and recoating. The NDE inspection showed no defects. Images below show the exchanger as delivered, and the tube-IDs after grit-blast cleaning, and the application of a new Curran Coating.

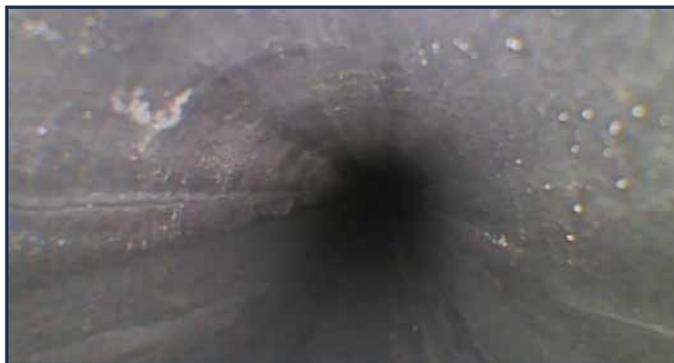
Tube-ID after coating removal, IRIS clean.

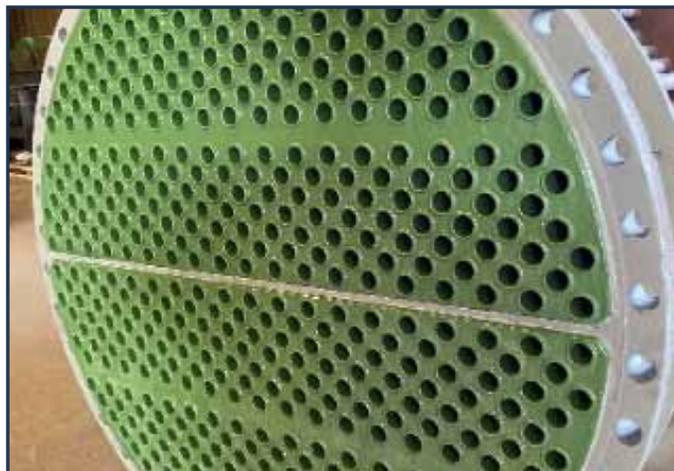
Coated exchanger, inspected, hydrotested, ready for service

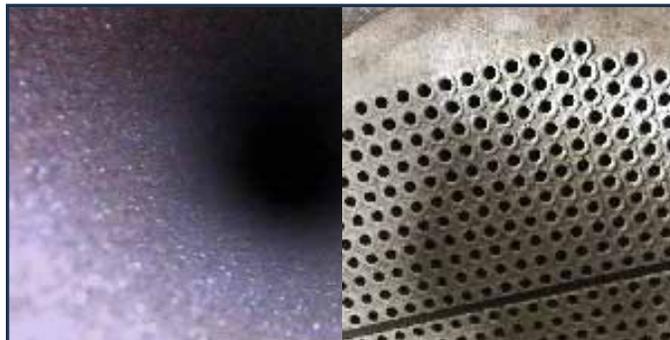
(Figure 1) Formerly coated exchanger and tubesheet, after Curran cleaning and coating removal for IRIS NDE.

The exchangers were Curran cleaned, the tube-ID coating removed from the one exchanger prior to IRIS NDE. Images of the tubes after cleaning are shown on the next page. The ID of the tube pictured in Figure 1 was coated. The ID of the tube pictured in Figure 2 was not coated.

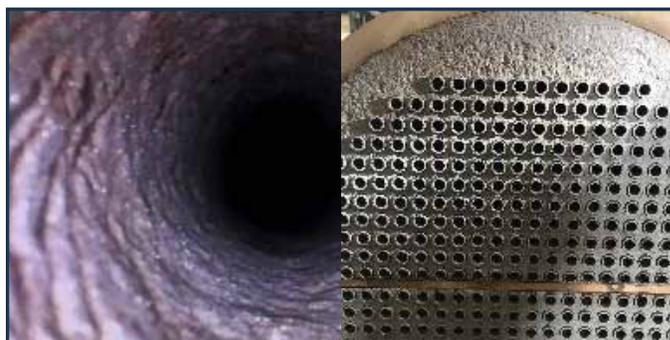
(Figure 2) Uncoated exchanger and tubesheet, after Curran cleaned for IRIS NDE.

As one can see, the tube in Figure 2 shows generalized surface corrosion down the tube-ID. Tubesheet images showed the same conditions. NDE results were not made available for these exchangers, but these images are telling.
