Protecting Exchanger Parts

Tube sheets, Channels, Covers, and Floating Heads

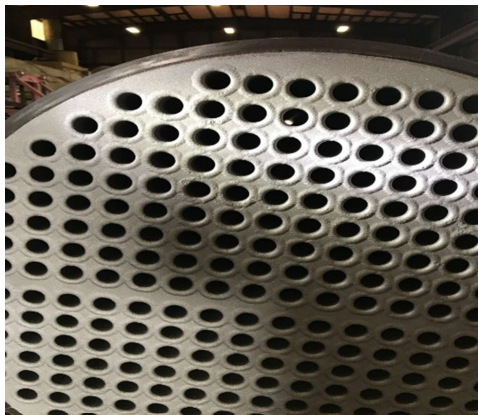
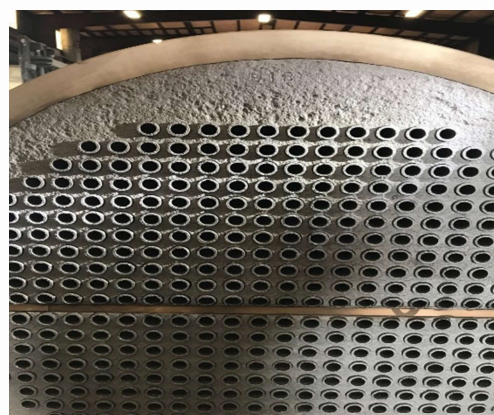
The proper selection in coating materials can be the difference between an application that lasts for 1 year and one that could give you multiple turnarounds. Below are pictures of sister cooling water exchangers that were installed by a client in 2011. The tube sheet on the left was coated with Curran 1000 and the one on the right was not coated. The below pictures were taken in May 2018 post coating removal by grit blasting. The Coated tube sheet shows almost like new condition where the uncoated one shows pitting corrosion.
