## Condenser Tubesheet Repair / Condenser Tube Lining

Single Pass unit with approx 8,000 CuNi tubes X 20 long  
Tube-sheet Brass

Matson – SS Matsonia

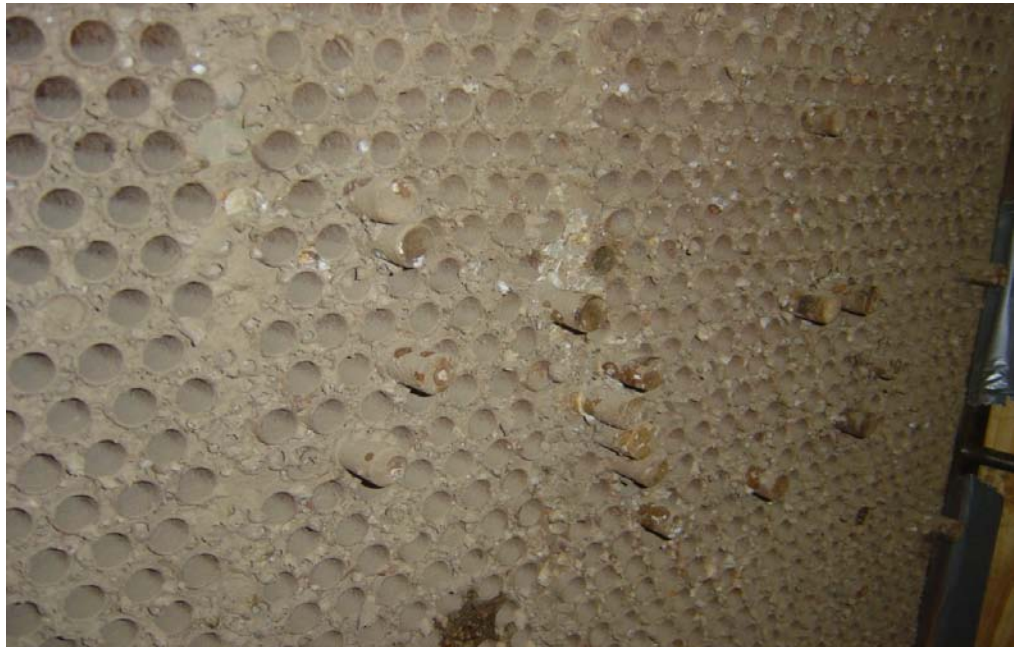
Tube-sheet prior to surface preparation (grit blasting). Note how the tube-sheet is worn away at the tube end.

Ships condenser was in need of repair. The condenser tubes were leaking leading to inefficient condenser operation. This was leading to condenser tubes having to be plugged and the need for unscheduled maintenance on the condenser while in port. The client had three options; 1) to re tube the condenser, 2) to keep plugging the condenser tubes and dealing with the maintenance, or 3) apply a thin film coating to the tubes to stop the condenser tubes from corroding. The client was trying to get 5 more years out of the condenser, but the tube corrosion required them to attempt to repair the condenser before that time. Because re tubing the condenser would have cost 4 times the cost of coating the condenser tubes, the client opted to have Curran International apply coating to the condenser tubes and tube sheet. Also a condenser re tube would have been difficult in the bottom of a ship where space is limited. Below are pictures and a summary of the condenser repair project.

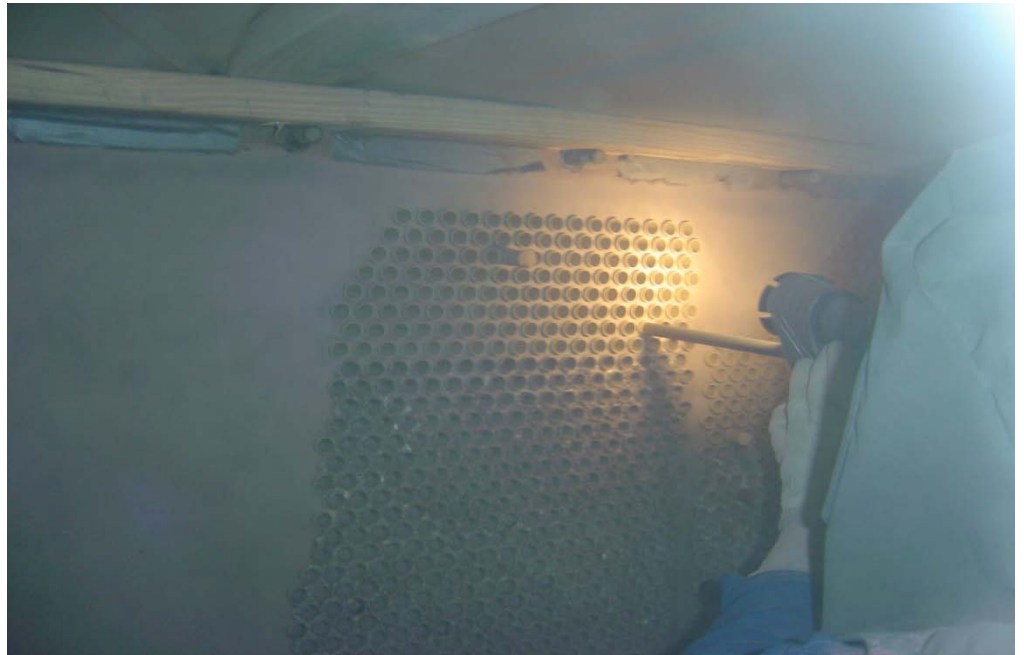
Condenser tube sheet and tubes being grit blasted

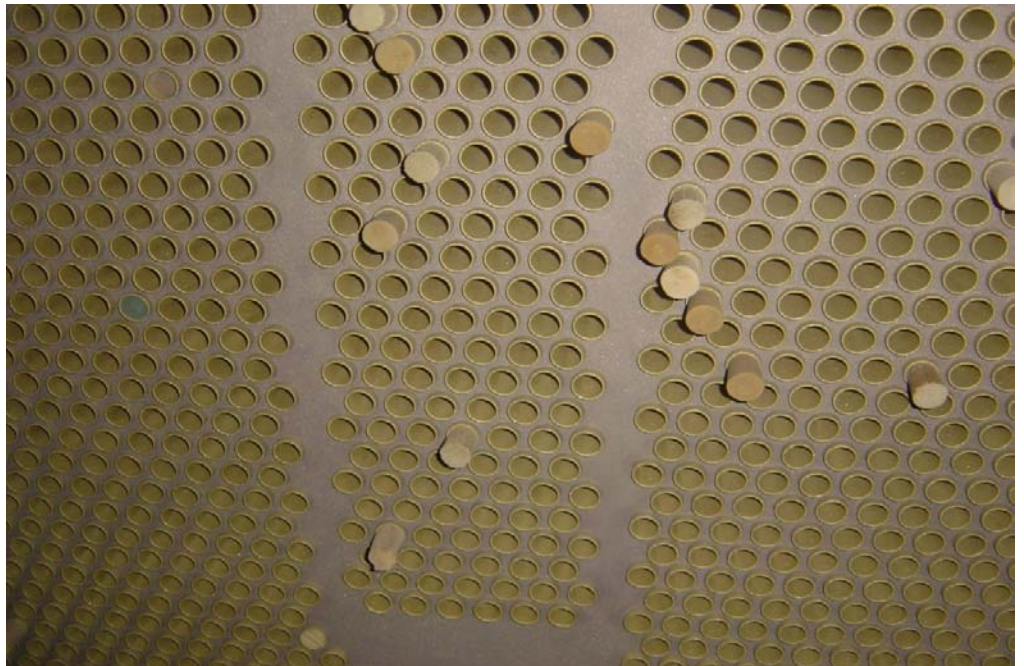
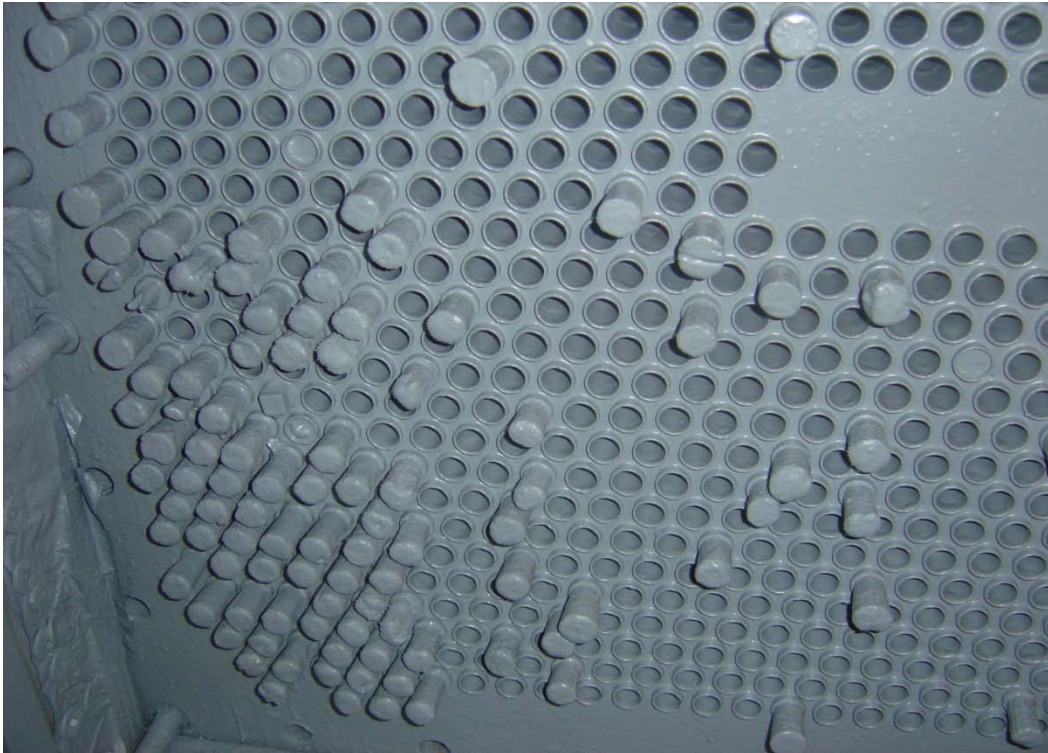
Condenser tube sheet and tubes after grit blasting for surface preparation
