A Once in-a-Generation Restoration

A Recent International Project – Reviewed

PFA Coatings Improve Valve Reliability in Corrosive Service

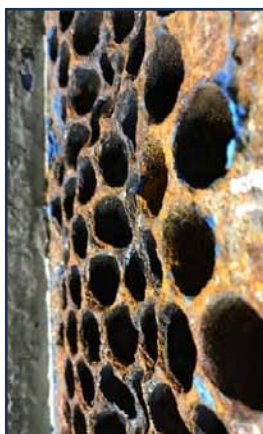
There was no cooling water cathodic protection system in place and, as a result, tubesheets were heavily pitted from ongoing galvanic attack.

Tubesheets suffered severe corrosion, there was no cathodic protection system

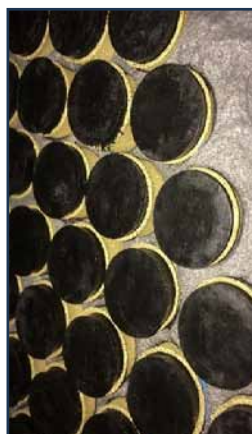
Immediately following the re-tube, Curran prepared the inside of the waterboxes for tubesheet coating application. Butyl plugs protected the new tubes during the grit blast surface prep of the tubesheets to NACE 1 "white metal" cleanliness. A forming plug was then used to set thickness of the polymeric epoxy cladding system.

Tubesheet cleaned to "white metal," forming plugs set to gauge coating thickness.

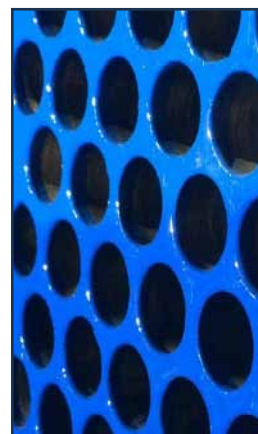
Firstly, a liquid grade epoxy "prime" coat wetted-in corroded pits at tube/tubesheet joint crevices. Then, a compatible high-build polymeric cladding was troweled across tubesheets. A top coat liquid epoxy left a glossy finish completing the coating work. The epoxy filled pitted areas, protects and inhibits new corrosion at a uniform finish of about 180 mils across the tubesheet.

Tubesheet restoration complete using Curran International's polymeric epoxy cladding system.

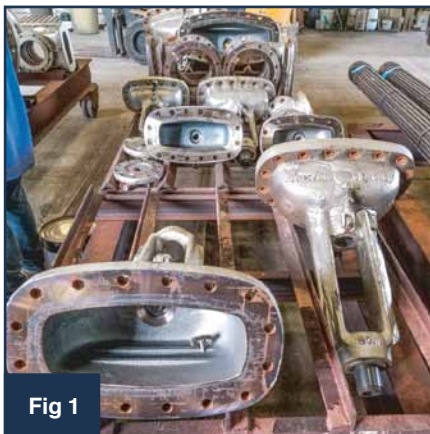
Fig 1

A refinery client had specified a PFA coating application for a series of gate valves used in corrosive fluid service (see Fig 1). The material of construction for the valves was carbon steel, and the PFA coating was added to the design specification to improve service life. Stainless steel pipe will be connected to the coated valves.

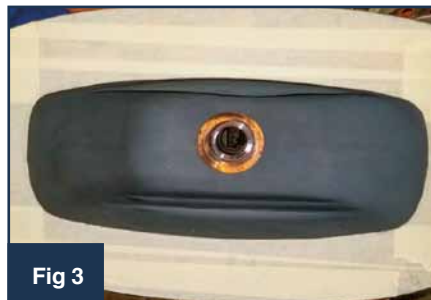
Fig 3

In figure 3 a prime coat application at a precise thickness is essential to coating system success. In figure 4, please note a coating technician using a fine spray to apply the coating.

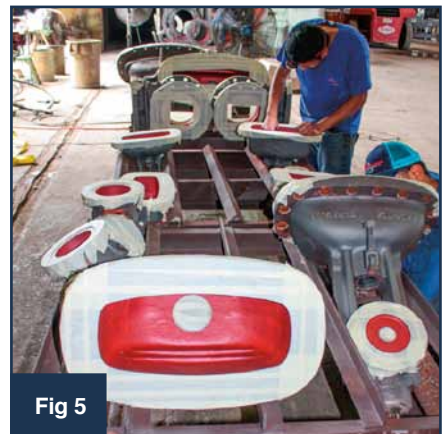
Fig 5

The PFA system requires a heat cure at 650°F with each coat; Curran has a convection oven large enough for batched loads of components. The cure cycle can require more than 24 hours of controlled heat up and cool down. Yet, the curing process cannot be hurried. If the coating is heated too quickly, it can delaminate and the coating process will need to be started over. (See figures 5 & 6 for finished products.)

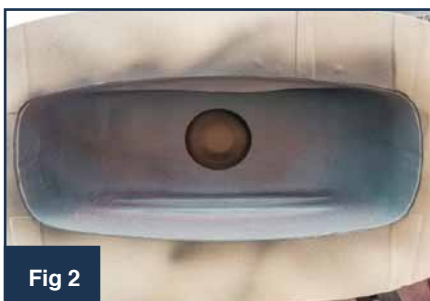
Fig 2

As part of the coating specification, the gasket seating areas at the flanges were masked and protected (see Fig 2) at the direction of the client. All surfaces to be coated were grit-blasted to NACE 1 "white metal" cleanliness. The grit blasting created an anchor-profile for the coating application.

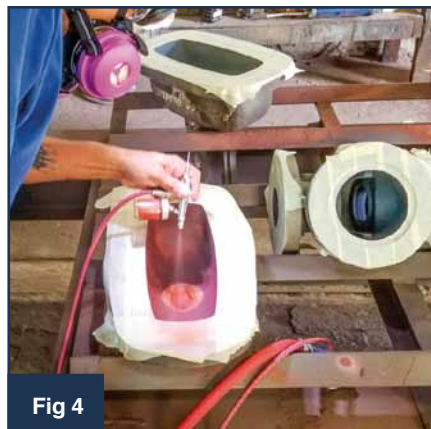
Fig 4

The coating system is delicate and can be easily done incorrectly. Several coats are applied to reach the desired thickness, as well as ensure a pinhole-free surface. Holiday testing is performed to check for pinholes.
